NASA
Technical Memorandum 106361

Metallographic Analysis of Brush Bristle and Integrity Testing of Brush Seal in Shroud Ring of T-700 Engine

Prepared for the
Fifth International Symposium on Transport Phenomena and
Dynamics of Rotating Machinery
sponsored by the Pacific Center of Thermal Fluids Engineering
Kaanapali, Maui, Hawaii, May 8-11, 1994

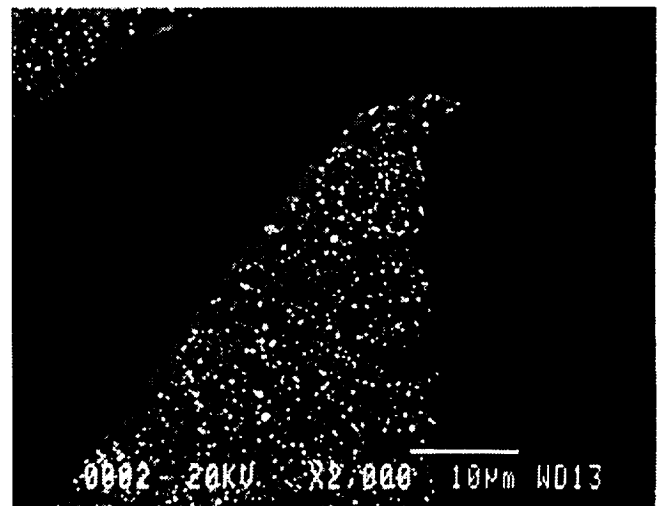
Figure 4.—Post-test analysis of bristles cut from brush seal, showing irregular tips.

Bristle tip irregularities caused by the rub interface (Fig. 4) indicate some form of material transfer and material smearing. However, metallographic analysis of the bristle near the rub tip showed tungsten-rich phases distributed throughout the bristle with no apparent change within 1 to 2 μm of the interface. From the Blok problem (Carslaw and Jager, 1959) the temperature was sufficient to melt the bristle, but the materials may fail in shear before melting (like pulling a taffy), form oxides and pits, transfer to the interface or form layers less than 1 μm thick, wear away, or all of the preceding.

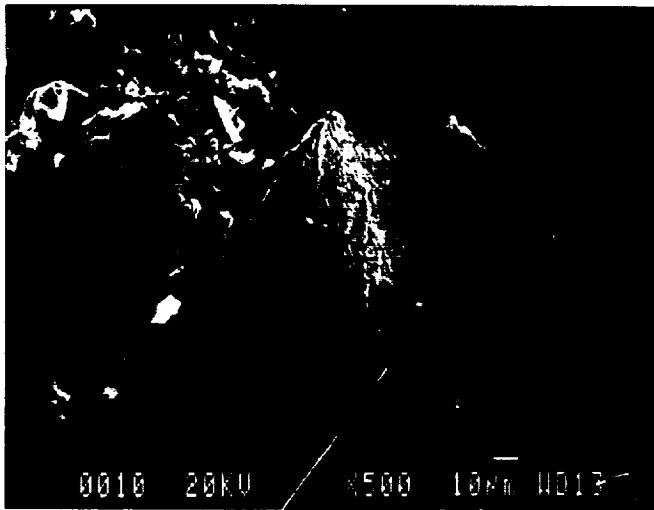
Figure 5.—Wear surface and oxidation with element composition.

Figure 5 illustrates a wear surface, although the angle does not always represent a wear surface. From 2 μm to several millimeters from the interface, there appears to be no change in tungsten composition. Green dots are near the edge (micrometer range) and red is away from edge (millimeter range), showing little or no change in tungsten distribution, but the surface appears to be coated (oxides are discussed later).

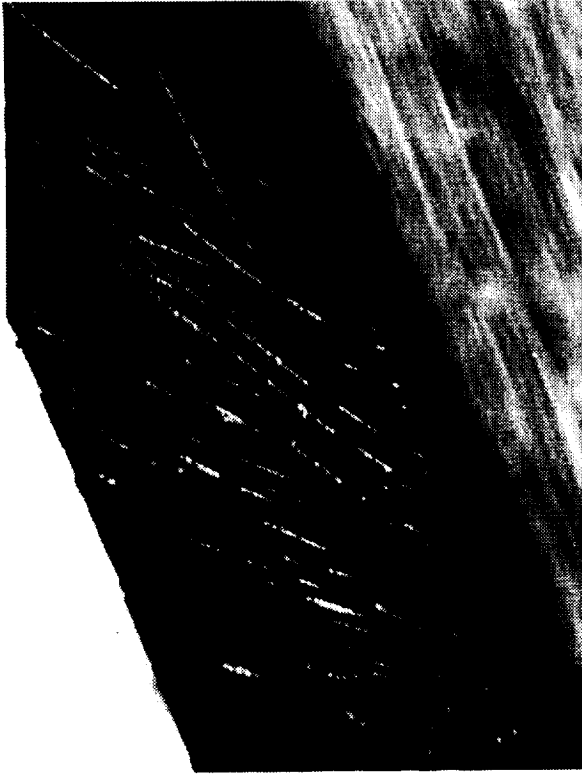
(d) Bristles caught within turbine blade gaps.

The post-test brush seal was examined by using a micro-video system. Several irregularities associated with installation were noted. One region was void of bristles; perhaps they were yanked out (Fig. 13(a)). Adjacent bristles were all bent over, on the leading edge but not in the core (Fig. 13(b)). One bristle of original length was kinked at the tip and appeared to be approximately 2.5 times as long as the remaining bristles (Fig. 13(c)). A closer look revealed some "snapped" bristles in that region, perhaps from forcing the brush into position or from catching bristles within the turbine blade gaps (Fig. 13(d)). The snapped bristles were very close to the pinch washer. Bristles near the pinch washer were broken or bent, but deeper into the brush bristle pack (N_x) the bristles were straight and worn (Fig. 13(e)). The appearance of the first three rows N_x of the brush showed
